McCOOK FIELD REPORT, SERIAL No. 1902

STATIC TEST OF THE LOENING PA-1 SINGLE-SEATER PURSUIT AIRPLANE

Prepared by
D. B. Weaver
Engineering Division, Air Service
McCook Field, Dayton, Ohio
April 10, 1922

STATIC TEST OF THE LOENING PA-1 SINGLE-SEATER PURSUIT PLANE.

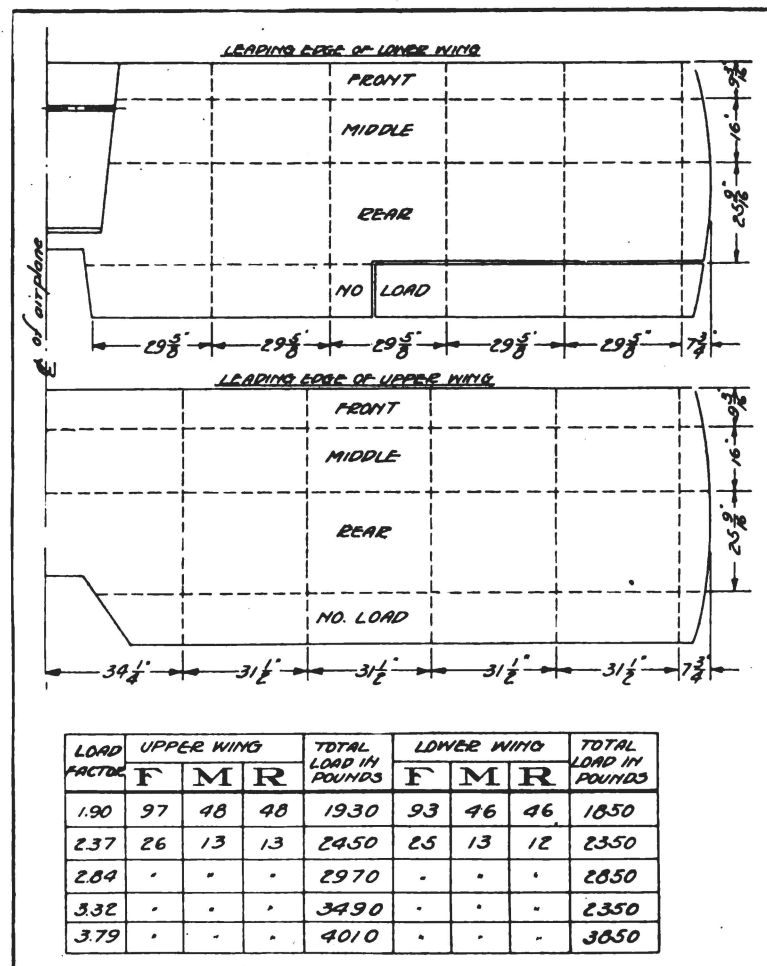
FIG. 10.—Loading schedule for the reverse load static test of the Loening PA-1.

The load was applied according to the loading schedule (Fig. 10). After a load had been put on and supported for five minutes, deflection readings at 10 points along the spar were taken and the retreat of the wing tips measured as indicated in Figure 11.

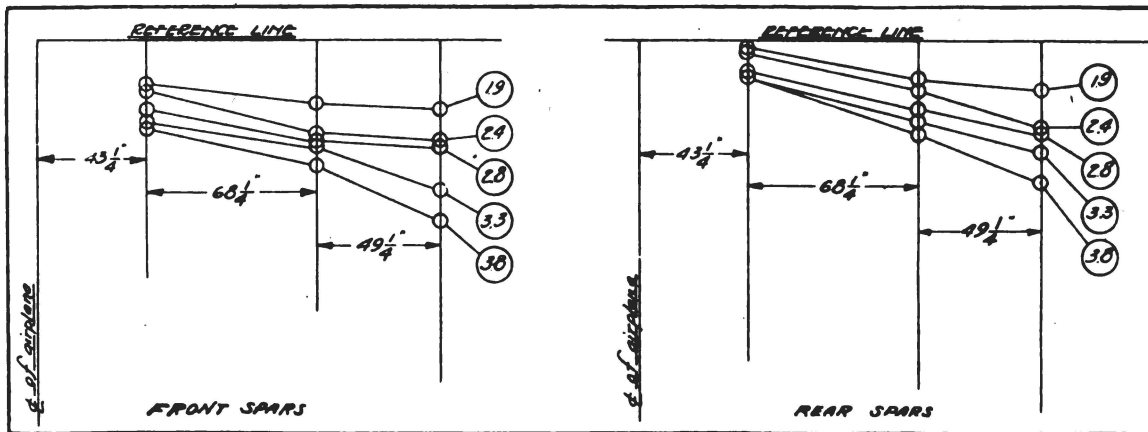
FIG. 12.—Curves showing mean deflection of the wing spars at points indicated during static test for reverse flight condition on the Loening PA-1.

of an inch. For tabulated results and spar deflection curves, see Figures 11 and 12.

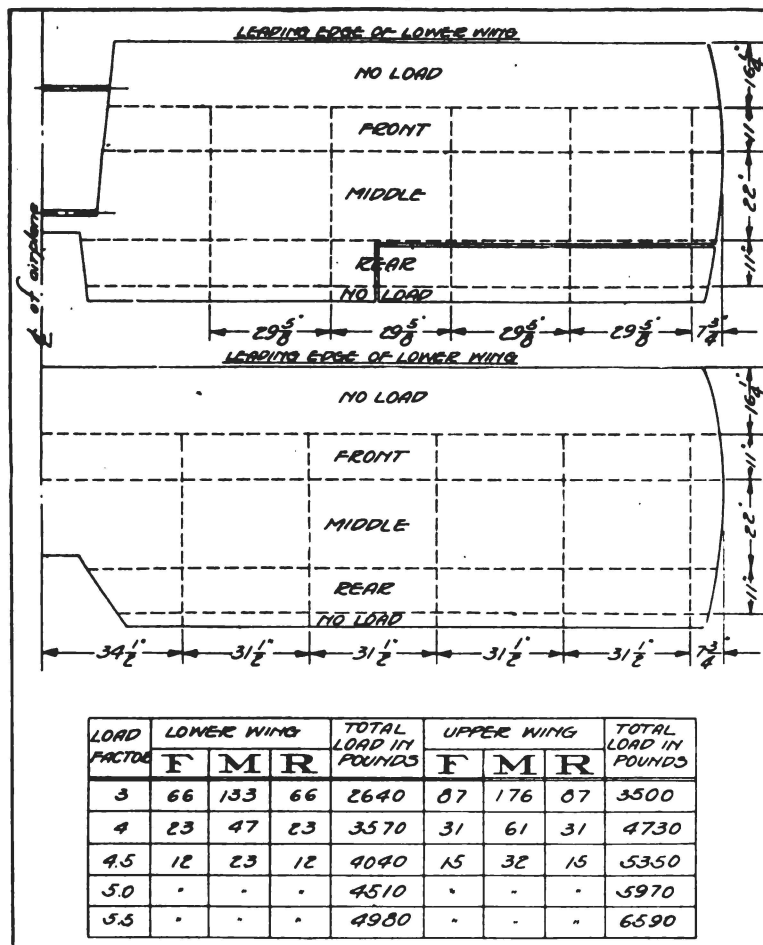
FIG. 13.—Loading schedule for the low angle of incidence static test of the Loening PA-1.

The load was applied according to the loading schedule, Figure 13. At the points indicated in Figure 14, deflection and retreat readings were taken after each load increment had been supported for five minutes.

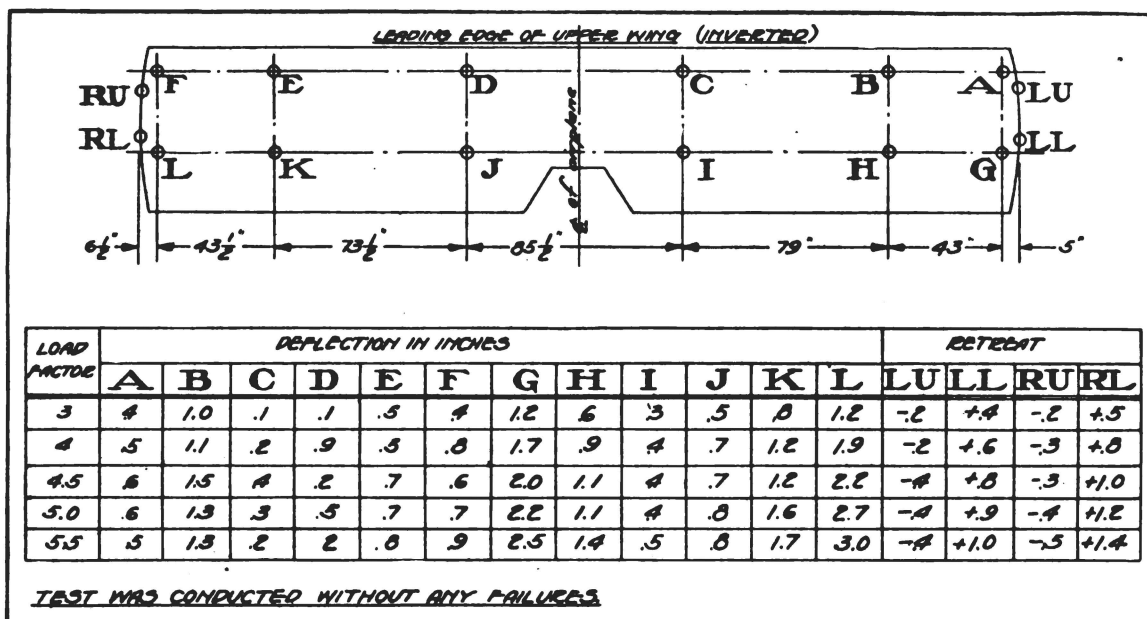
FIG. 14.—Tabulated results of the low angle of incidence static test of the Loening PA-1.

Figures 14 and 15 give the spar deflections and wing tip retreat in tabulated form.

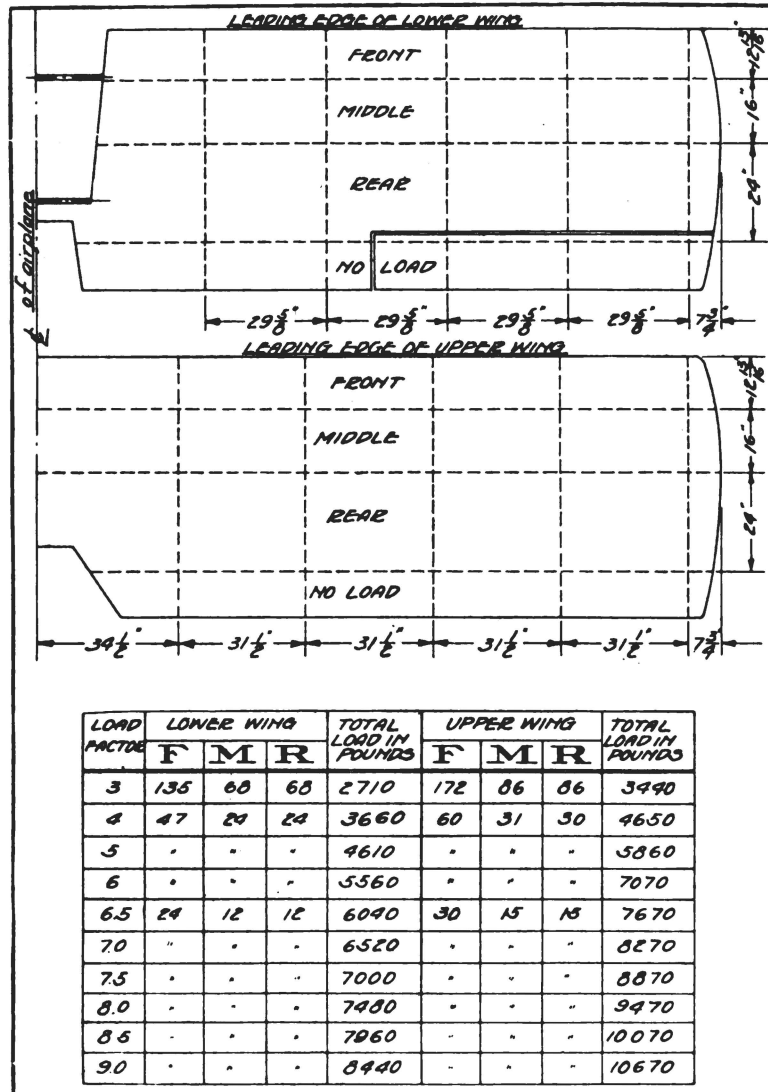
FIG. 16.

The loads were placed according to the loading schedule, Figure 16. Deflection and retreat readings were taken at points indicated in Figure 17, after each load increment had been supported for five minutes.

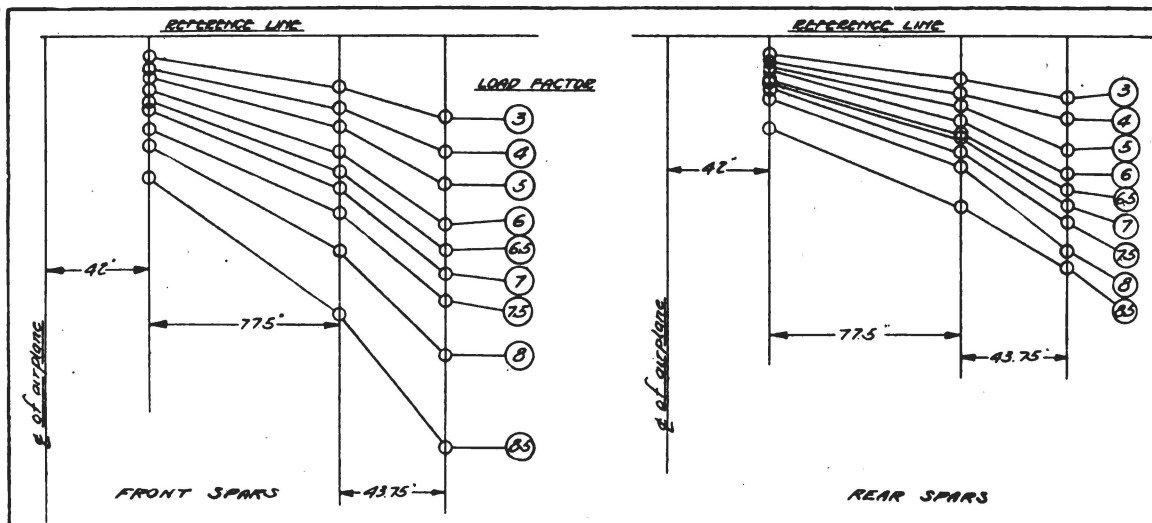
FIG. 18.—Curves showing mean deflection of the wing spars during static test for high incidence condition of the Loening PA-1.

Deflections of the wing spars and wing tip retreat are given in tabulated form, Figure 17. Figure 18 gives the wing spar deflection curves.

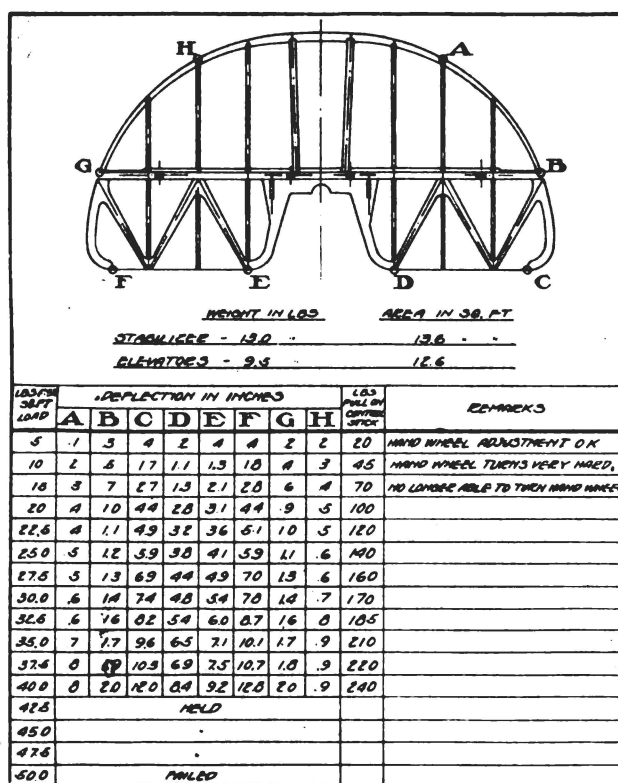
FIG. 26.—Tabulated results of the static tests of the Loening PA-1 elevators and stabilizers.

figure 26. The failure, with both sides of the elevator broken, is shown in figure 27.

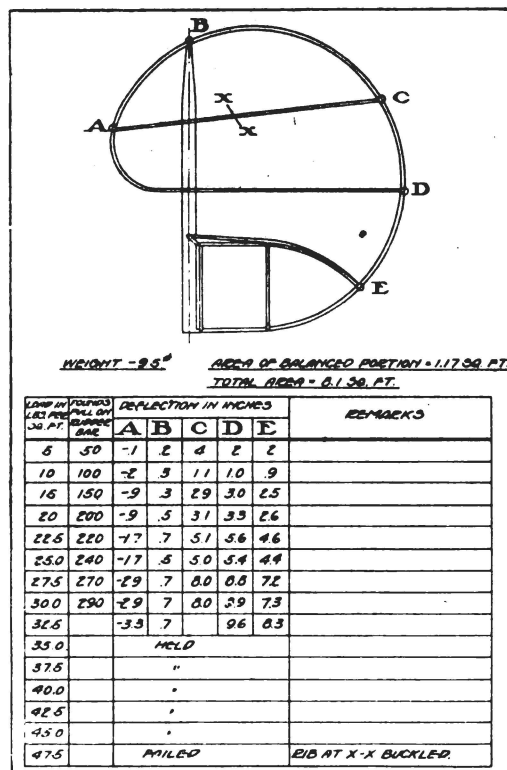
FIG. 29.—Tabulated results of the static test of the rudder on the Loening PA-1.

The rudder supported the required load of 30 pounds per square foot without failure. The loading was continued until failure of the ribs resulted at 47.5 pounds per square foot. Figure 29 gives the pull necessary to actuate the rudder under load and the deflection of the surfaces at the points indicated. Figure 30 is a photograph of the rudder failure with the fabric cover removed.

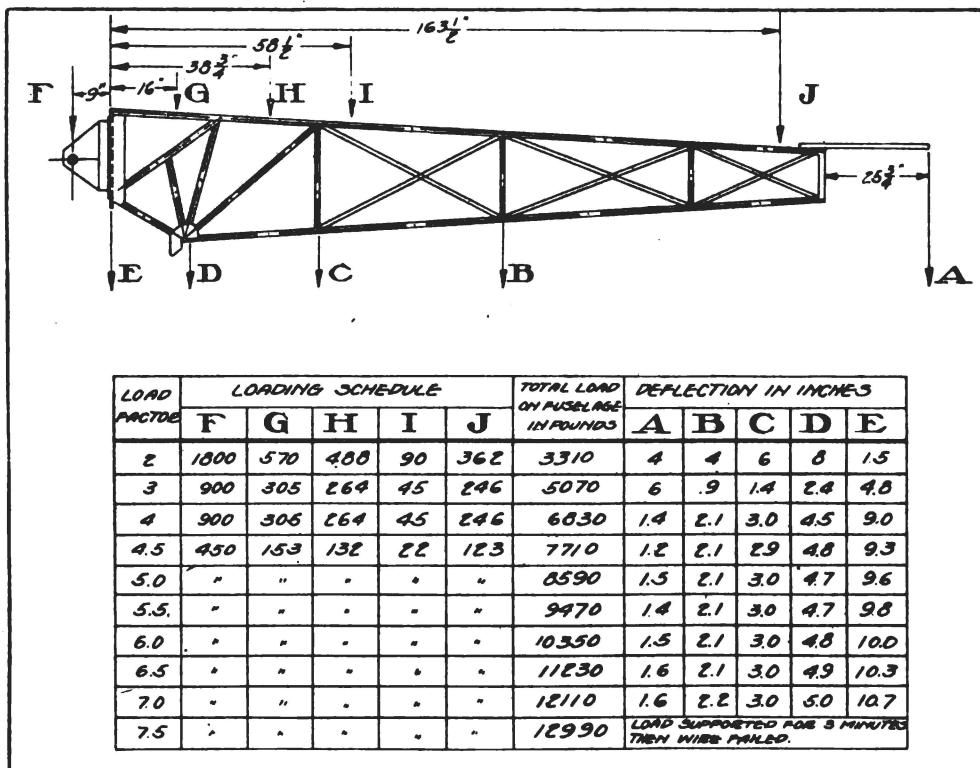
FIG. 32.—Loading schedule and chart of deflections of the Loening PA-1 fuselage during static test.

The load was applied at five points, A to E, inclusive, figure 32, according to the loading schedule. Scales were suspended from four points, figure 32, from which deflection readings were taken by means of a wye level. The load increments were supported for five minutes before readings were taken.

When the jacks were let down at a load factor of 4, the right upper wing spars failed in compression, the ribs failed in compression, and a drift wire pulled in two. A load factor of 7.5 was supported for three minutes, when a wire in the second to the last bay, left side, failed. The wire was replaced, and after supporting a factor of 8 for five minutes failed again. With a three-sixteenth inch flexible steel cable in place of the wire the test was continued. The lower longerons buckled in the third bay from the tail end, at a factor of 8. Figure 33 is a photograph of this failure.
